Cessna 150 Safety Review Part 2

By Brian Lowe

Cessna 150 Safety Review

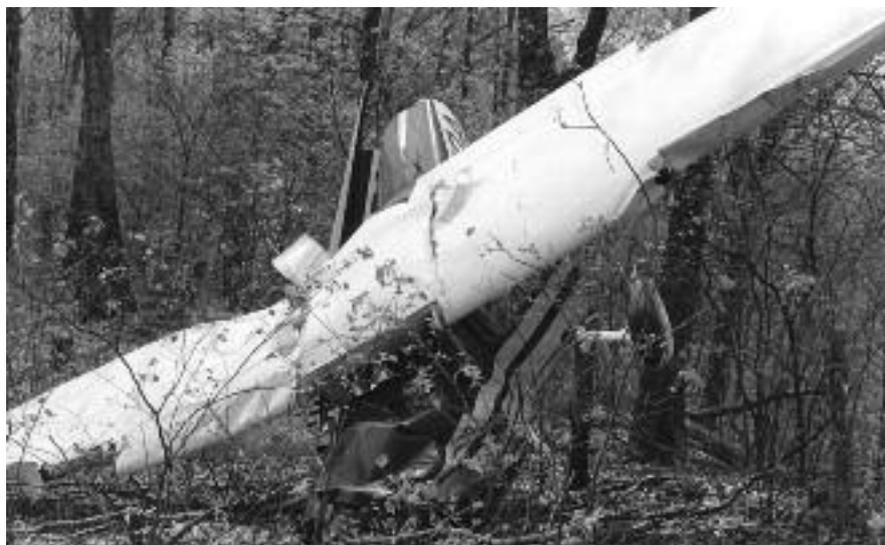
The 140 originally had independent left and right tanks with the feeding tank being selected by a Left-Right fuel valve. Each tank had its own vented fuel cap. In later models the fuel selector valve was modified to allow fuel to also flow from "Both" tanks. A cross vent between the two

tanks was also added.

When designing the 150, Cessna decided to dispense with the left and right fuel flow selections and designed the fuel system to constantly feed from both tanks. The cross vent was retained and a vent tube was added to the left wing, venting the left tank while the right tank retained the vented fuel cap.

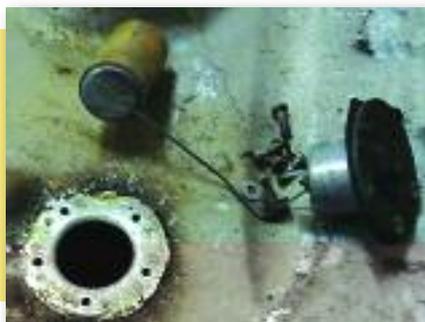
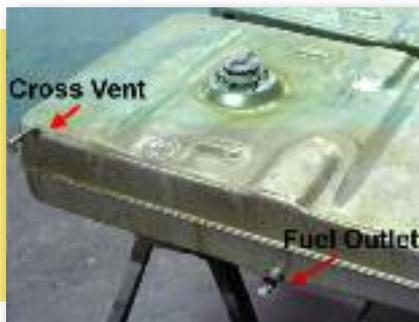
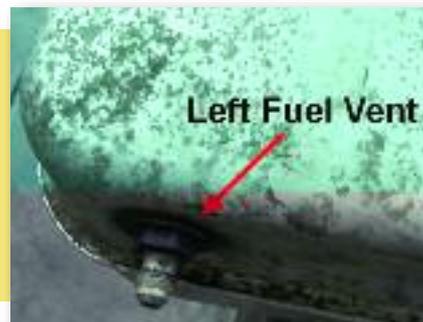
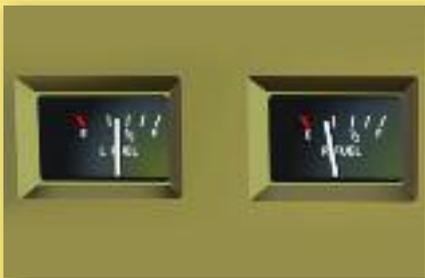
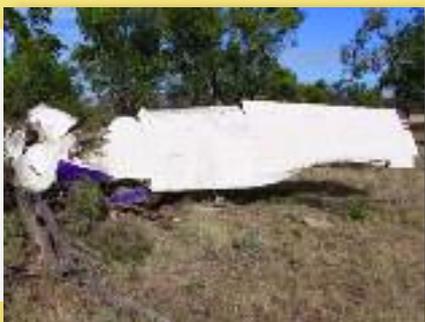
The type certificate of the 140A states its unusable fuel is 2 US Gallons

per tank. It seems strange therefore; that the Cessna 150 which has the same fuel tank construction should have a lower (1.75 USG) unusable fuel quantity than the 140, particularly as the 150 has a far steeper nose down angle during descent with full flaps deployed.

Tests conducted by the Irish Air Accident Investigation Unit in 1999 following the crash of Cessna 150 EI-AUC determined that a Cessna 150 with 40 degree Flap deployed in approach configuration had an unusable fuel in excess of 2.11 USG which is 20% higher than that derived under CAR 3 and published in the 150's TCDS (Type Certificate) and POH (Pilot Operating Handbook).

The AAU's analysis suggested that the aircraft's real unusable fuel is at

least 0.72 USG (2.75 Litres) greater than that stated or 8 minutes less flight time, redefining the Cessna 150's actual unusable fuel figure as 4.22 US Gallons (or 16 Litres) - a massive 17% of total tank capacity.
